**LETTER REPORT  
FOR  
CLARK OIL REFINERY  
BLUE ISLAND, COOK COUNTY, ILLINOIS  
TDD: SO5-9802-018  
PAN: 8F1801PIXX**

**April 3, 1998**

Re: Clark Oil Refinery - Blue Island  
Blue Island, Cook County, Illinois  
TDD: S05-9802-018  
PAN: 8F1801PIXX

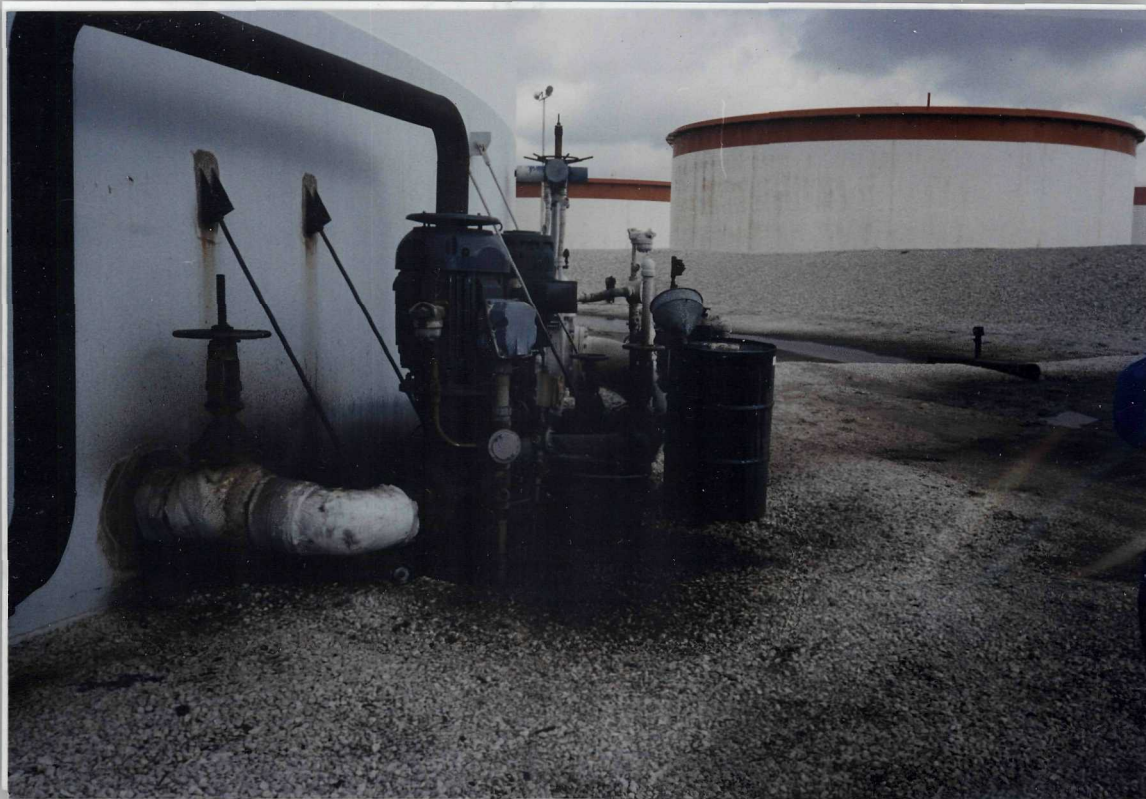
**TIME:** 10:05 **PHOTO:** 1

**SUBJECT:** Pump located at Tank 801. Oil sampling location.

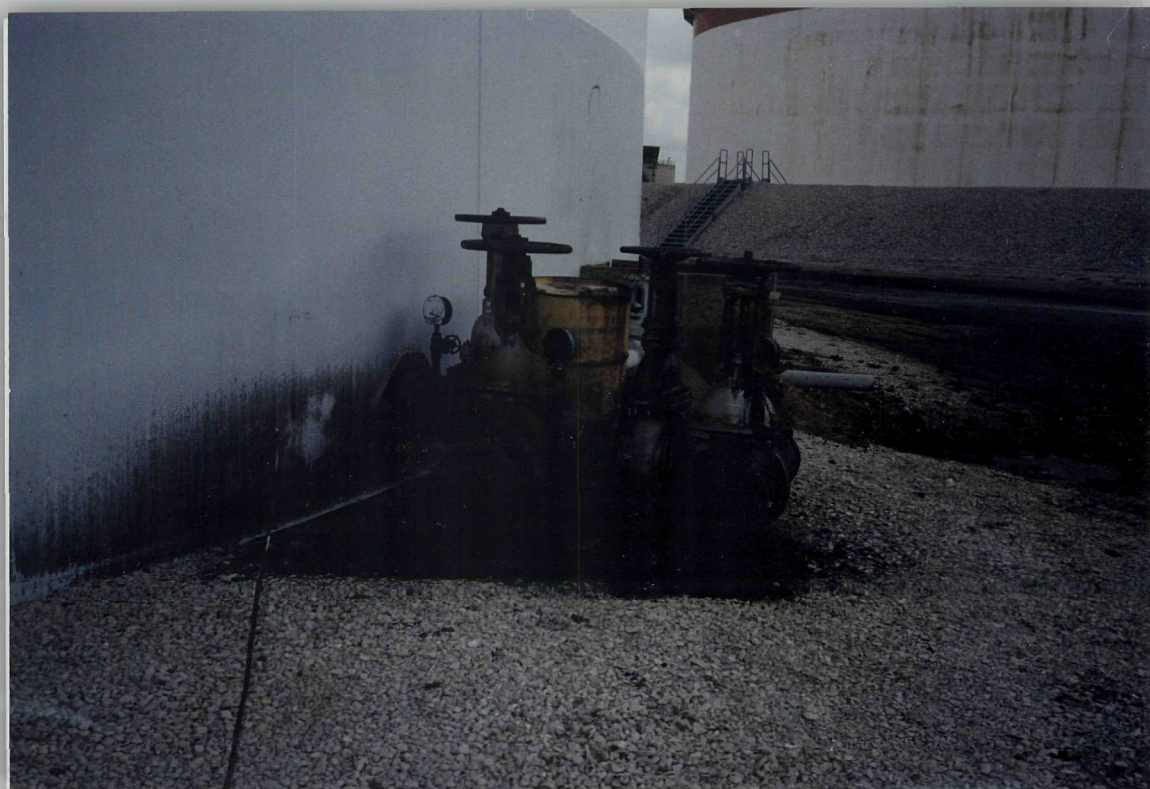
**TIME:** 10:10 **PHOTO:** 2

Attachment A contains the photodocumentation of the site inspection. The site consisted of the northwest tank farm areas (800 series tanks), the 40-, 60-, and 70-series tank farm area, and the southwest property tank farm (50 series tanks). Tank 801 was the first tank area inspected. The area beneath the pump and oil sampling port was heavily stained with oil (photo 1). Mr. Huval stated Clark Oil had a dedicated team whose job was to pump out oil catch pans throughout the facility. During the March 1997 inspection, a leak coming from a flange in piping associated with tank 801 was observed. This leak had been corrected, but the oil-stained soil remained (photo 2).

**SUBJECT:** Piping at Tank 801 which was leaking in March 1997. The piping is no longer leaking because flange was fixed, however, note oil-stained ground. The area shown in this photo is the same area represented in photo 1 from the March 1997 inspection.

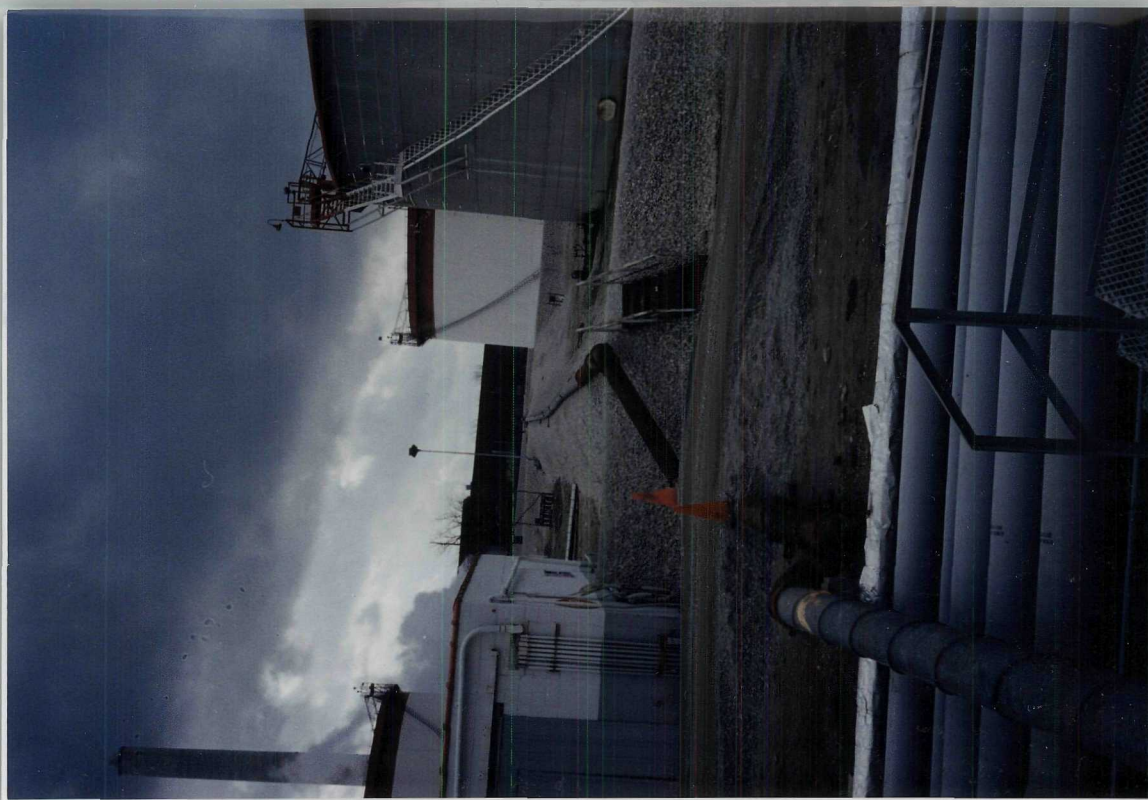
**TIME:** 10:20 **PHOTO:** 3  
**PHOTOGRAPHER:** Kirchner

**SUBJECT:** Water pipe that runs from 6 foot sewer junction box at the Cal-Sag Channel to Tank 45.

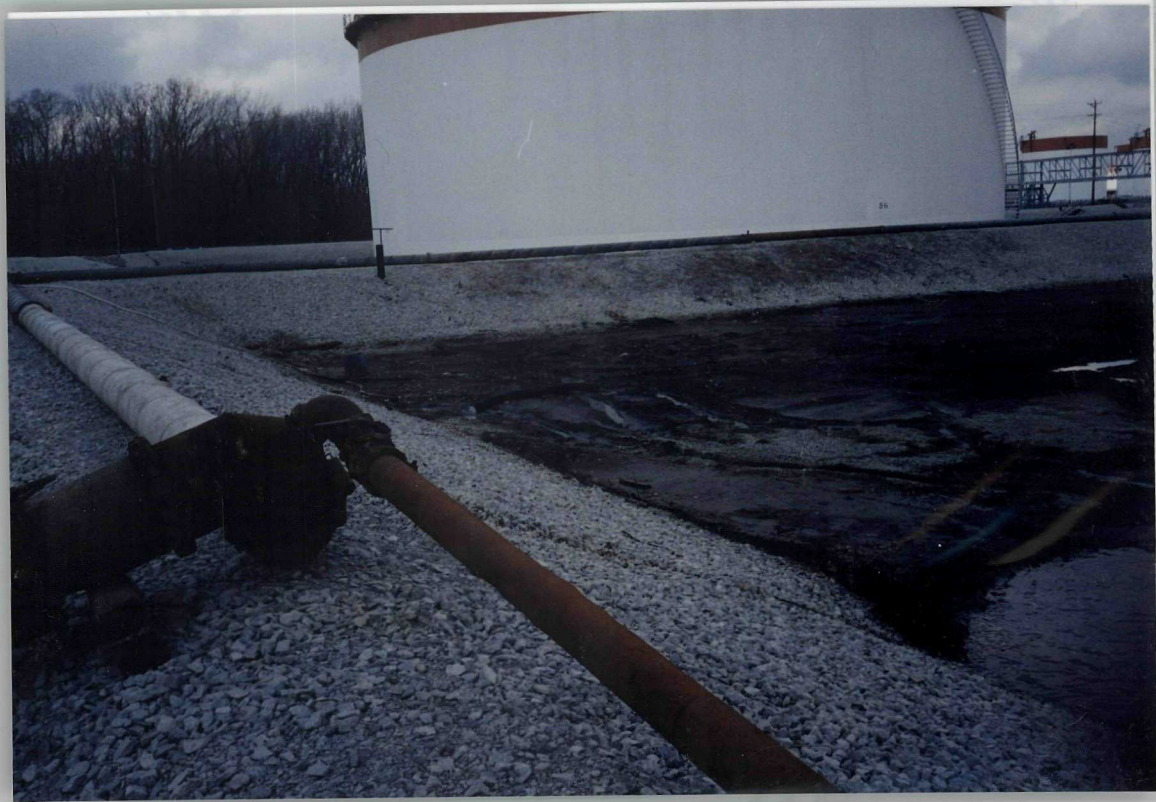
**TIME:** 10:25 **PHOTO:** 5

**SUBJECT:** Water is no longer pumped from 6 foot sewer junction box into containment area for Tank 55. Water is now piped to Tank 45.

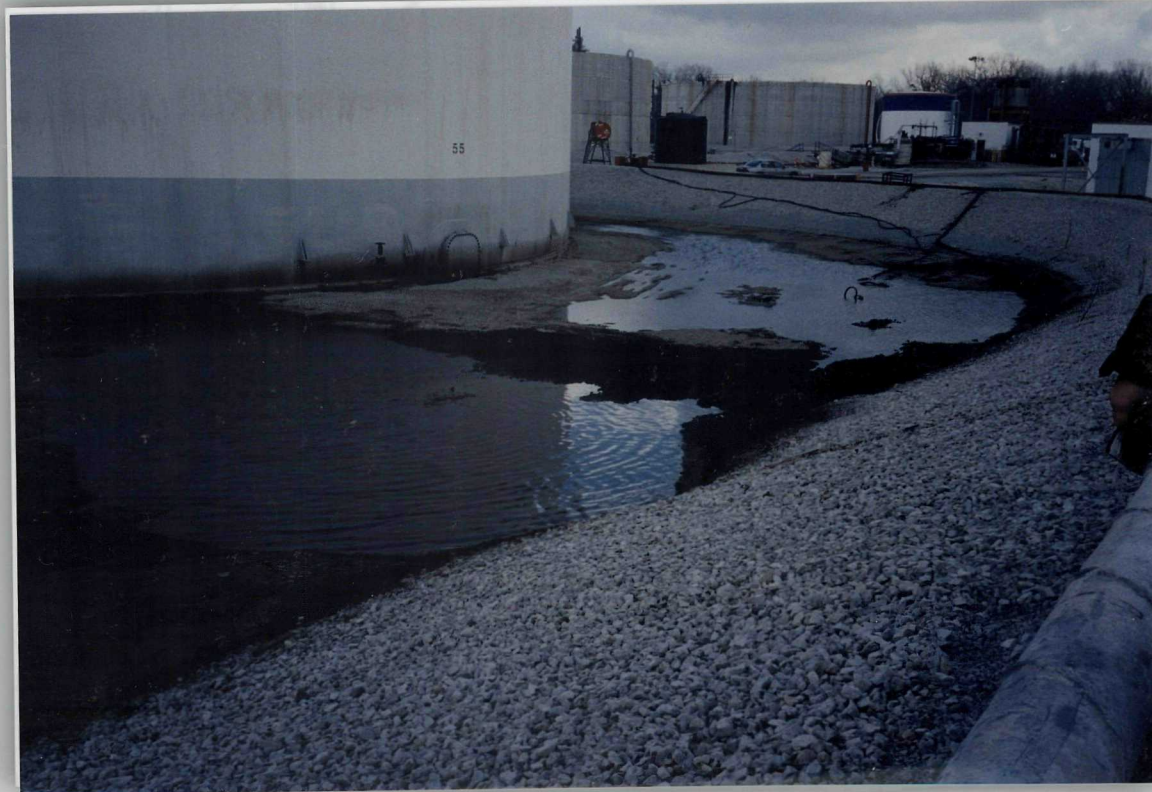
**TIME:** 10:40 **PHOTO:** 6

**SUBJECT:** Depression area around Tank 55 where water was pumped. Ground stained with product. The area shown in this photo is the same area represented in photo 2 from the March 1997 inspection.

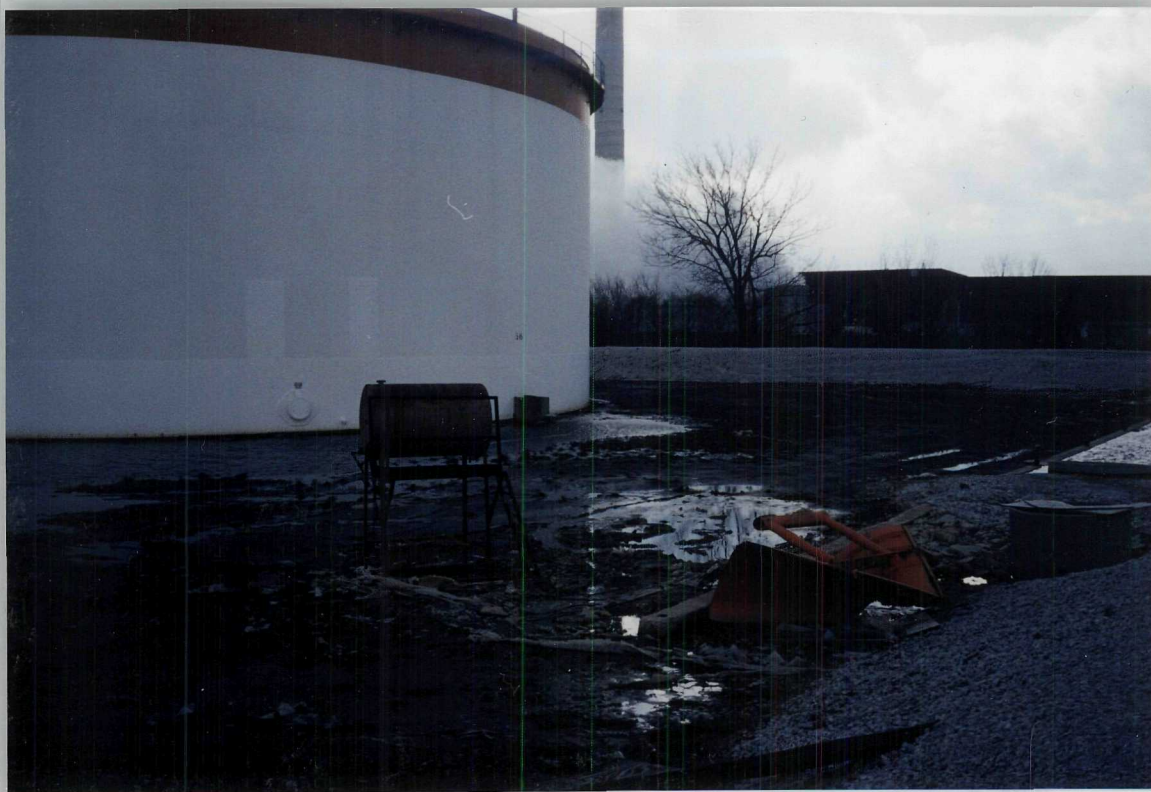
**SITE:** Clark Oil Refinery      **DATE:** February 27, 1998      **TIME:** 10:45      **PHOTO:** 7  
**LOCATION:** Blue Island, IL      **DIRECTION:** Southeast      **PHOTOGRAPHER:** Kirchner  
**SUBJECT:** Tank 56 containment area. Note debris and standing water in containment. There was no visible staining on floor of containment.

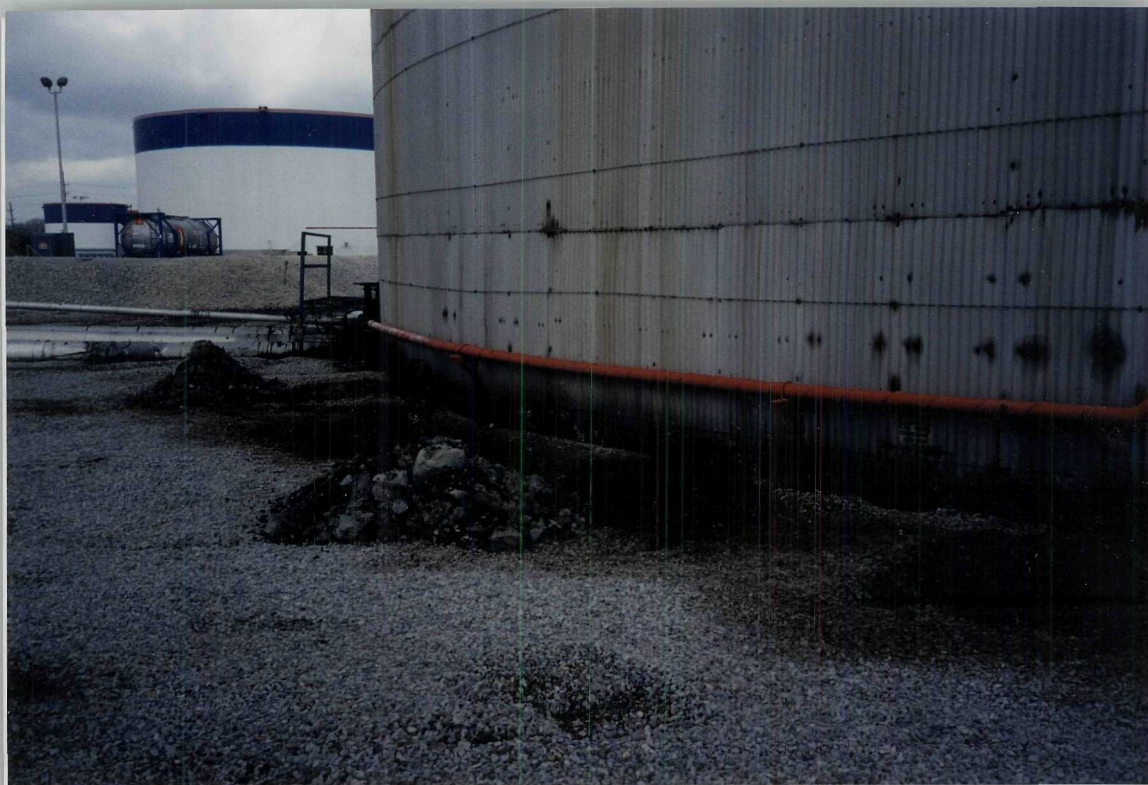
**SITE:** Clark Oil Refinery      **DATE:** February 27, 1998      **TIME:** 10:50      **PHOTO:** 8  
**LOCATION:** Blue Island, IL      **DIRECTION:** North      **PHOTOGRAPHER:** Kirchner  
**SUBJECT:** Insulated Tank 51 located in same containment area as Tank 59. Note staining on ground and around bottom of tank. Same containment area as photo 8 from March 1997 inspection.

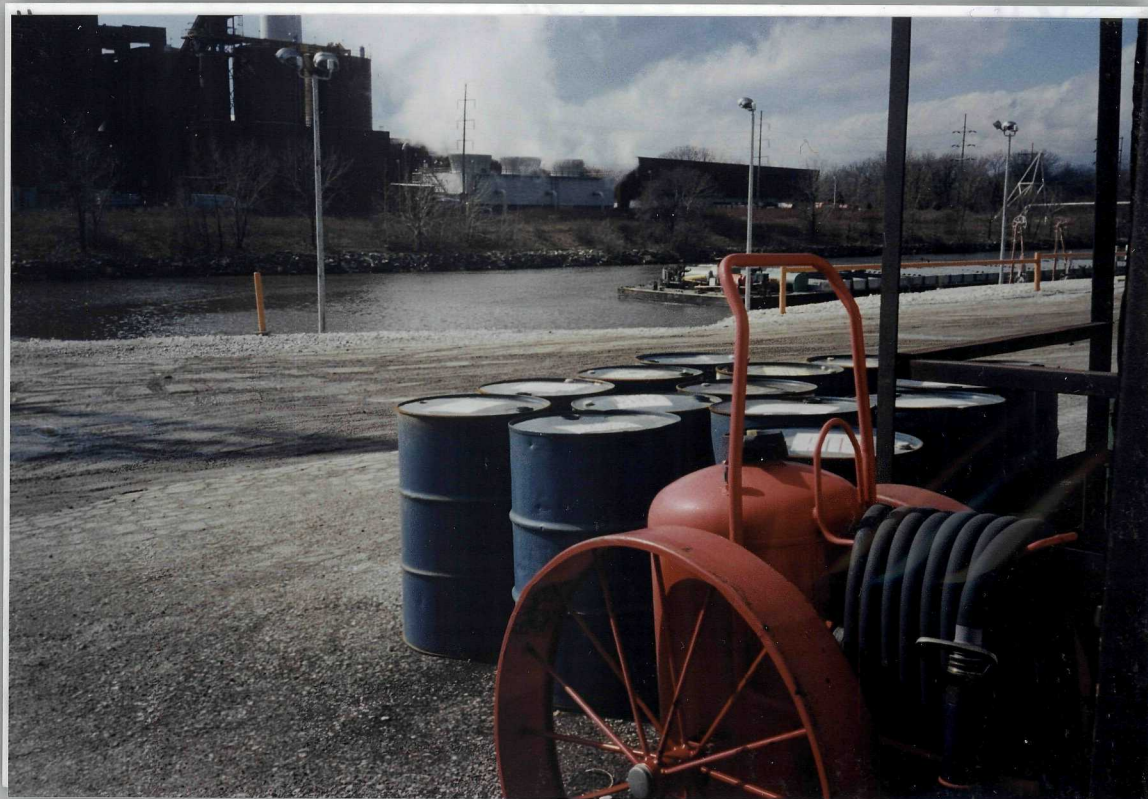
**TIME:** 10:50 **PHOTO:** 9

No changes had been made to the drum storage area next to the Cal-Sag Channel since the March 1997 inspection (photos 9, 10 and 11). Although the warehouse storing the full drums has cement curbing around the majority of the perimeter, there is no curbing at the entrance way. There is a slight slope away from the Cal-Sag Channel; however, this slope would not prevent a leaking drum near the entrance way of the warehouse from being contained within the cement curbed area. Also, several empty drums are stored outside the southern end of the warehouse with no secondary containment measures.

**SUBJECT:** Empty drum storage area and proximity of Cal-Sag Channel.

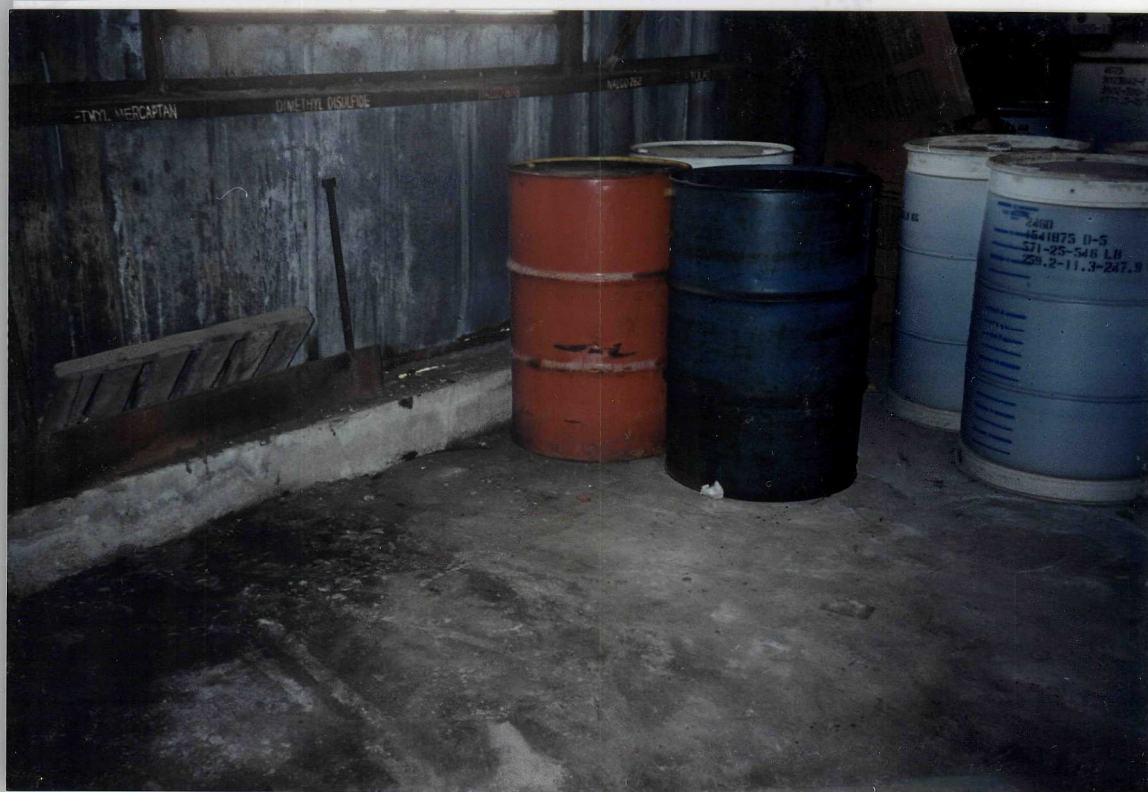
**TIME:** 10:55 **PHOTO:** 10

**SUBJECT:** Inside drum warehouse. Warehouse has cement curbing, except at warehouse entrance.

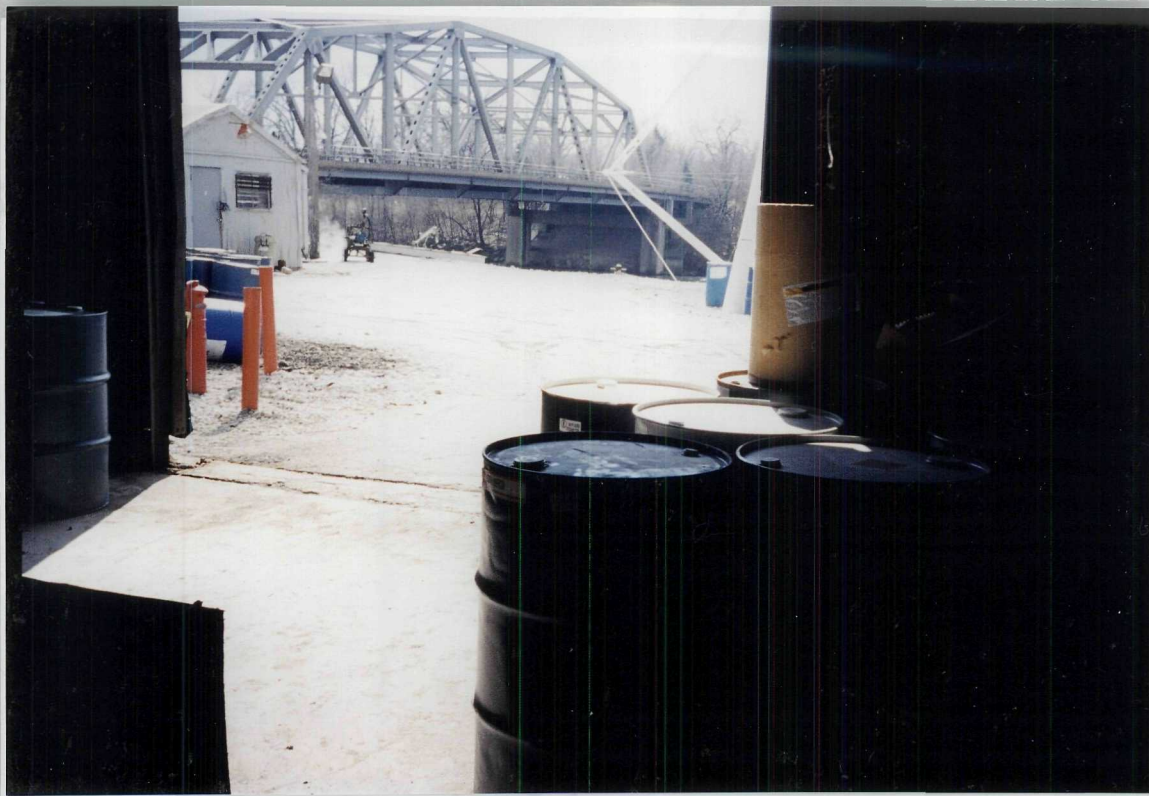
**SITE:** Clark Oil Refinery      **DATE:** February 27, 1998      **TIME:** 10:55      **PHOTO:** 11  
**LOCATION:** Blue Island, IL      **DIRECTION:** Southeast      **PHOTOGRAPHER:** Kirchner  
**SUBJECT:** Inside drum warehouse looking towards the Cal-Sag Channel. Warehouse has cement curbing, except along the doorway.

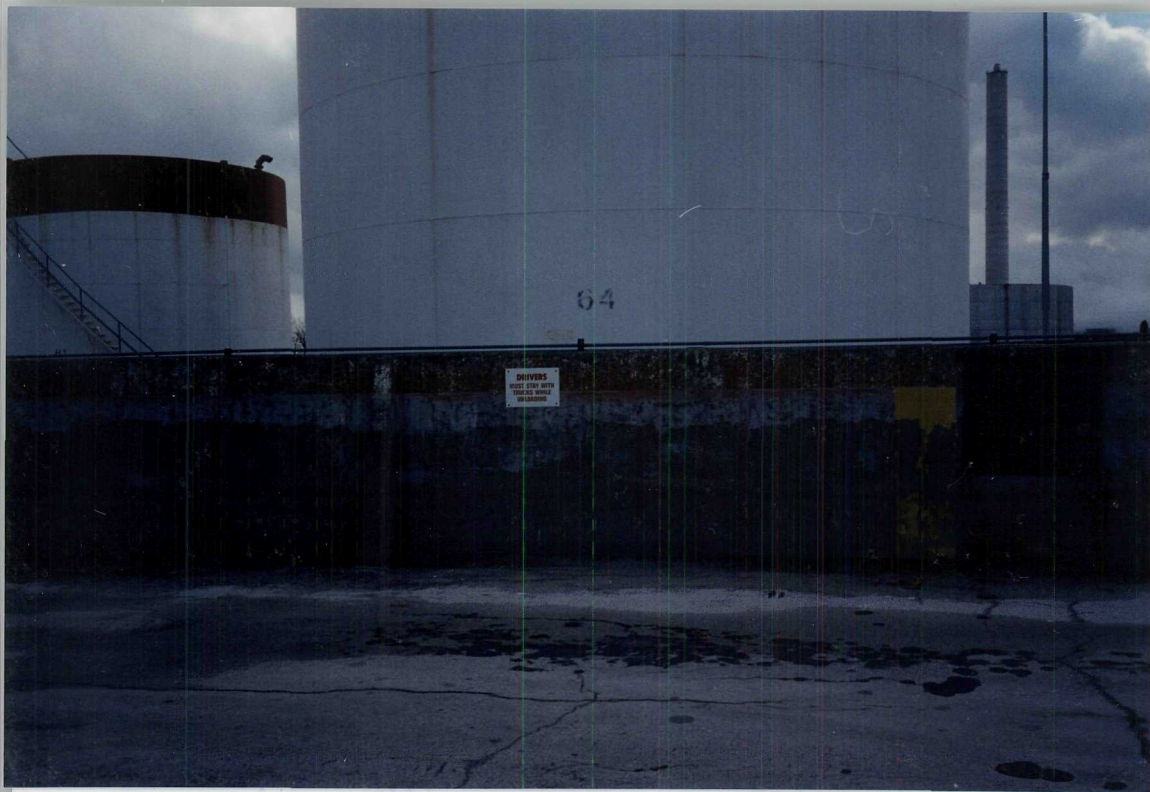
**SITE:** Clark Oil Refinery      **DATE:** February 27, 1998      **TIME:** 11:10      **PHOTO:** 12  
**LOCATION:** Blue Island, IL      **DIRECTION:** South      **PHOTOGRAPHER:** Kirchner  
**SUBJECT:** Visible unloading sign located on dike wall at LPG unloading area near light oil rack.

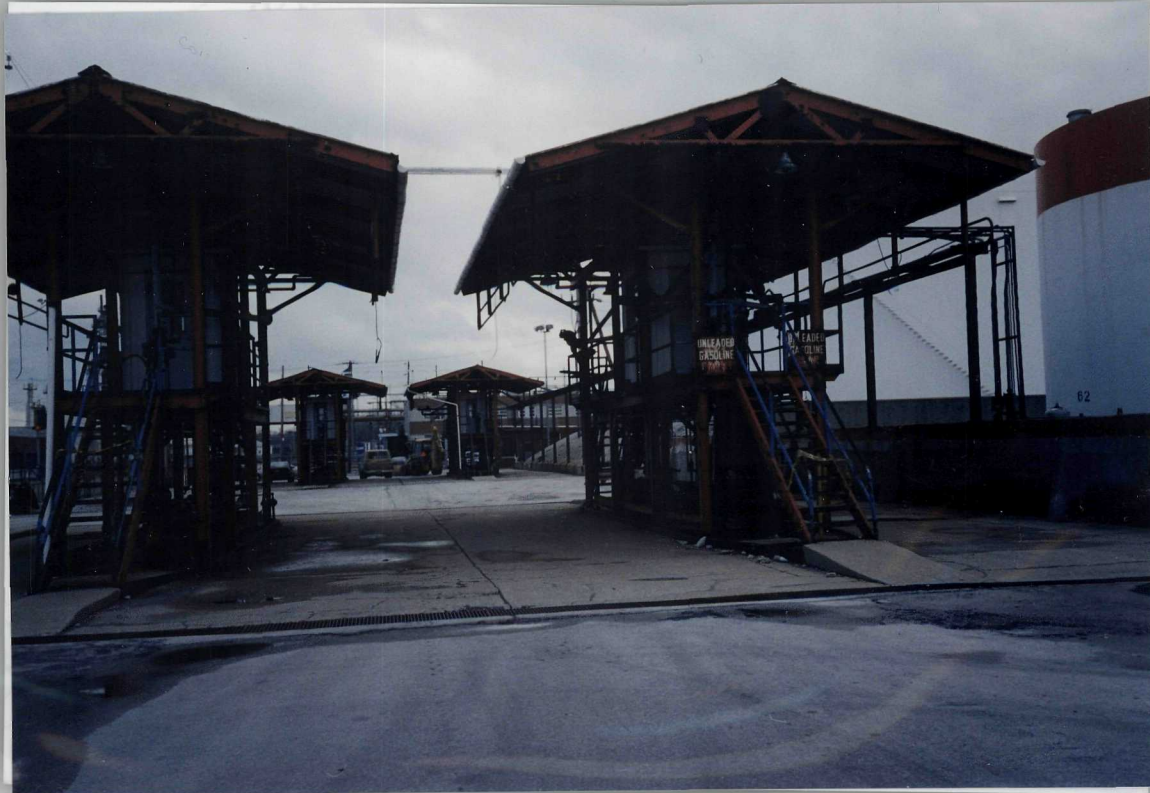
**TIME:** 11:10 **PHOTO:** 13  
**PHOTOGRAPHER:** Kirchner

- According to the plan on page 2-40, "warning signs are posted at the racks to warn drivers not to depart before all transfer lines are disconnected." Mr. Kennett was not sure if signs were posted or not posted. During the site inspection, it was noted that signs are not posted at the light or heavy oil loading racks.

Neither the light oil or heavy oil truck racks displayed warning signs for the drivers (photos 13 and 17). The only visible warning signs were displayed at an area next to the liquid propane gas (LPG) loading area (photos 12 and 14). Mr. Huval was not sure as to what products were unloaded at the station next to the LPG loading area. The facility does display signs warning drivers of overhead piping (photo 15). These signs are located on 131<sup>st</sup> Street.

**SITE:** Clark Oil Refinery  
**LOCATION:** Blue Island, IL  
**SUBJECT:** Absence of warning signs at light oil rack. SPCC Plan states that signs are present.

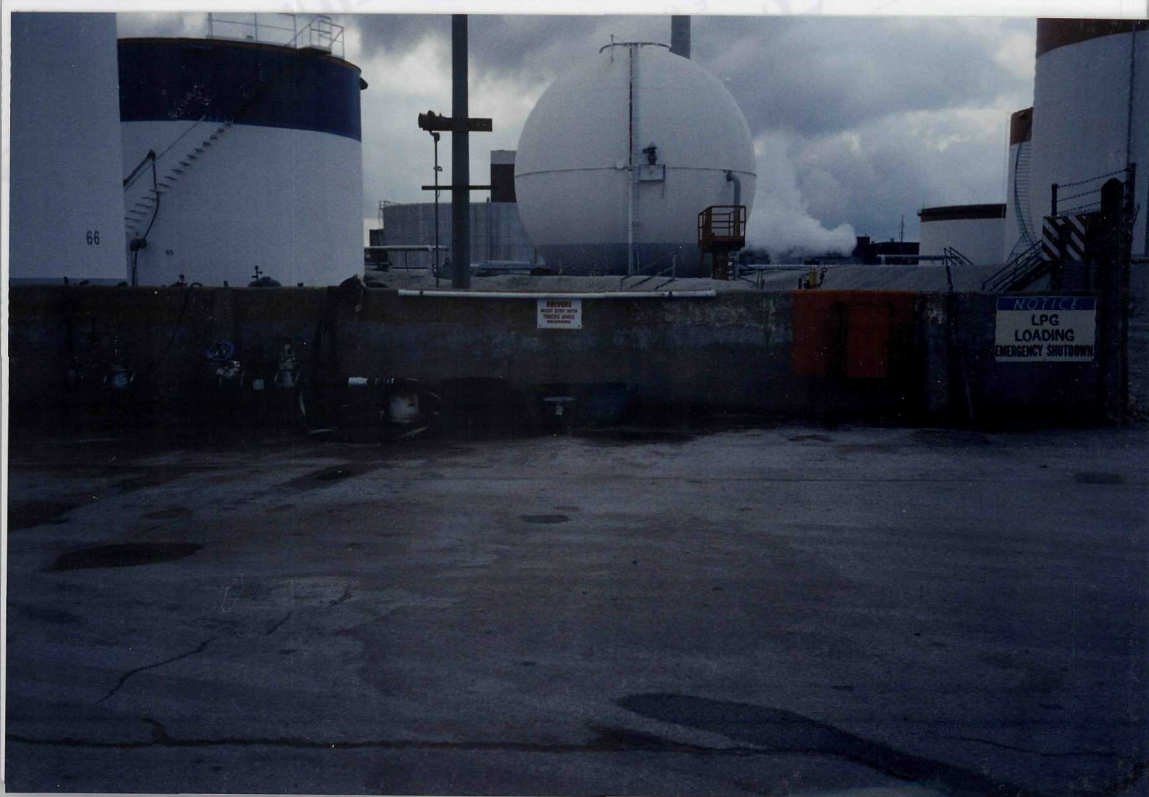
**TIME:** 11:10 **PHOTO:** 14  
**PHOTOGRAPHER:** Kirchner

**SITE:** Clark Oil Refinery  
**LOCATION:** Blue Island, IL  
**SUBJECT:** Visible unloading sign west of light oil rack near LPG loading area.

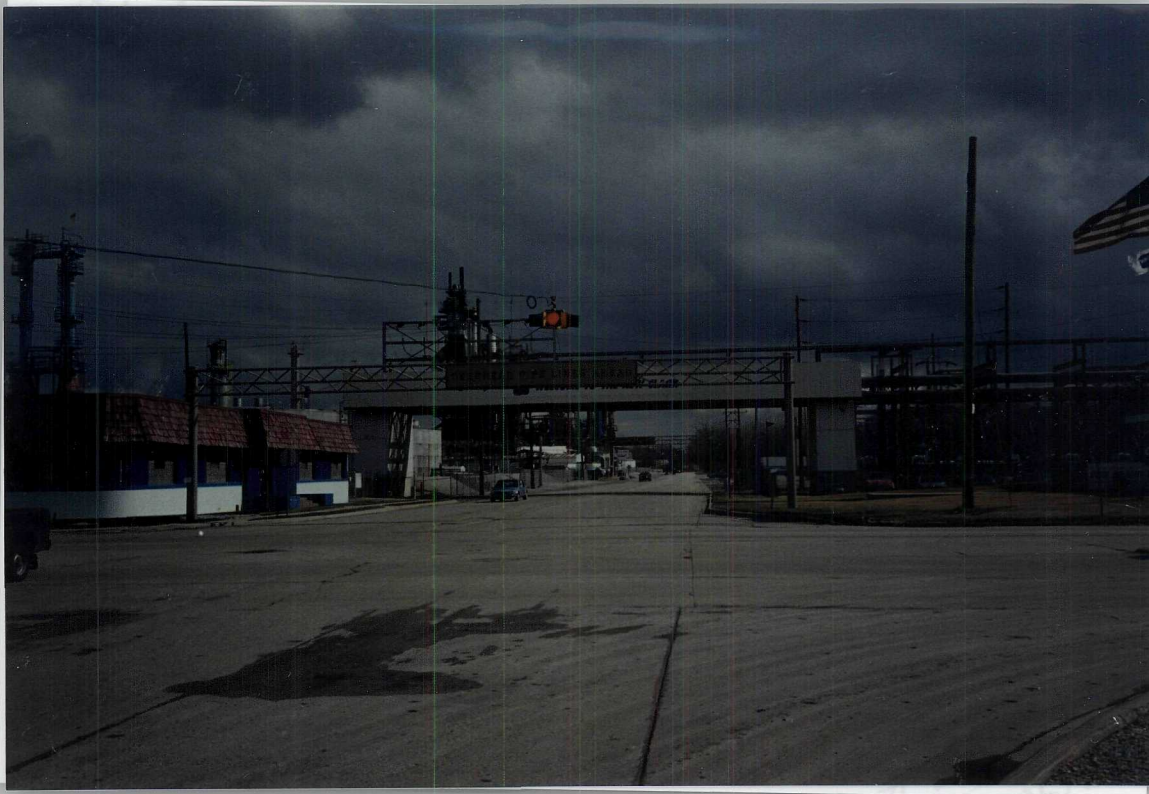
**SITE:** Clark Oil Refinery      **DATE:** February 27, 1998      **TIME:** 11:10      **PHOTO:** 15  
**LOCATION:** Blue Island, IL      **DIRECTION:** East      **PHOTOGRAPHER:** Kirchner  
**SUBJECT:** Sign, warning of overhead pipeline, located near the intersection of 131<sup>st</sup> Street and Kedzie Avenue.

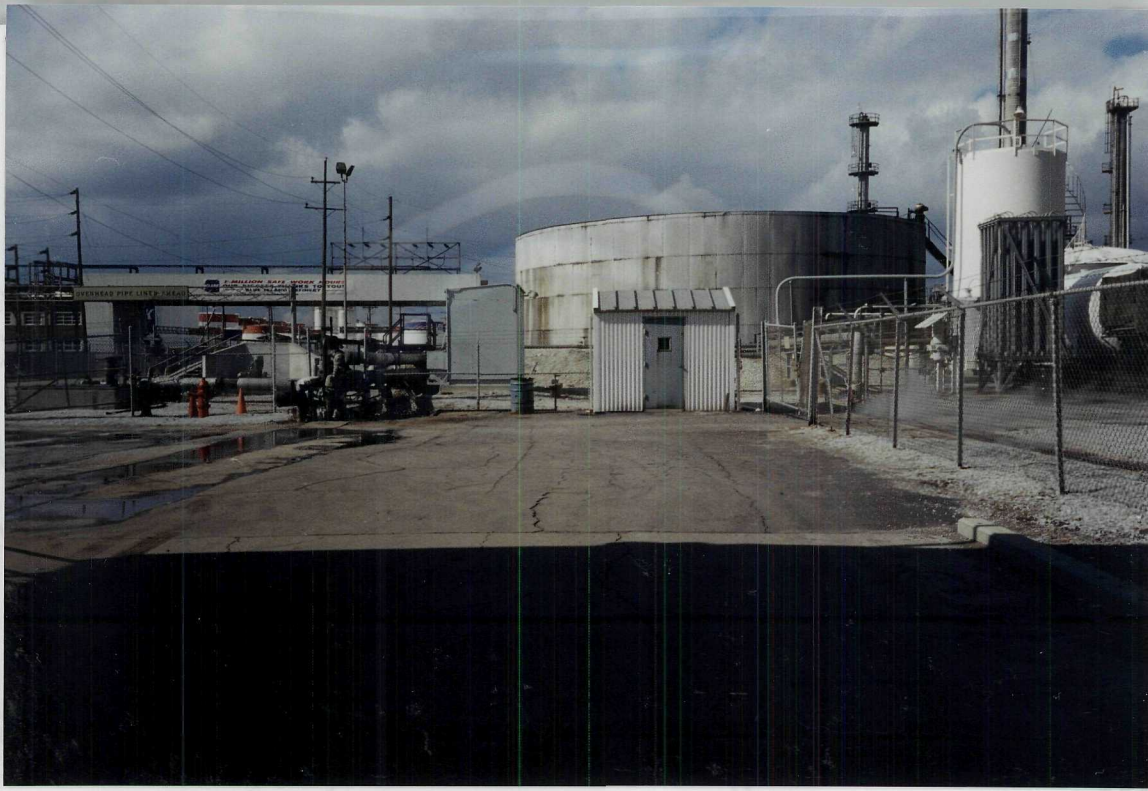
During the March 1997 inspection, two skid tanks were located next to a shed between junction box 38 and the heavy oil loading rack. These tanks were located in such a way that they did not have proper secondary containment. These skid tanks were not present at the time of the inspection (photo 16). Mr. Huval did not know when the tanks had been removed from the area.

**SITE:** Clark Oil Refinery      **DATE:** February 27, 1998      **TIME:** 11:20      **PHOTO:** 16  
**LOCATION:** Blue Island, IL      **DIRECTION:** West      **PHOTOGRAPHER:** Kirchner  
**SUBJECT:** Skid tanks which were located next to shed during March 1997 inspection have been removed. The area shown in this photo is the same area represented in the photo taken at 16:17 hours from the March 1997 inspection.

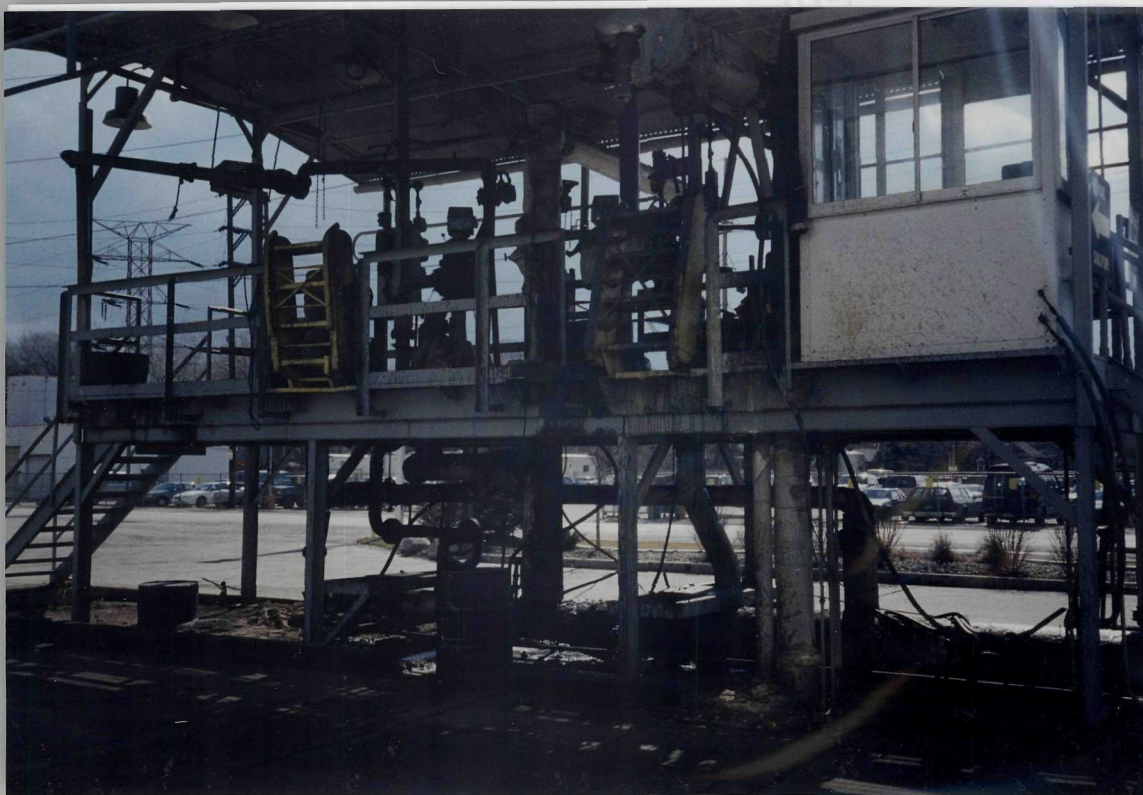
**TIME:** 11:25 **PHOTO:** 17  
**PHOTOGRAPHER:** Kirchner

**SITE:** Clark Oil Refinery  
**LOCATION:** Blue Island, IL  
**SUBJECT:** No warning signs posted in heavy oil rack.

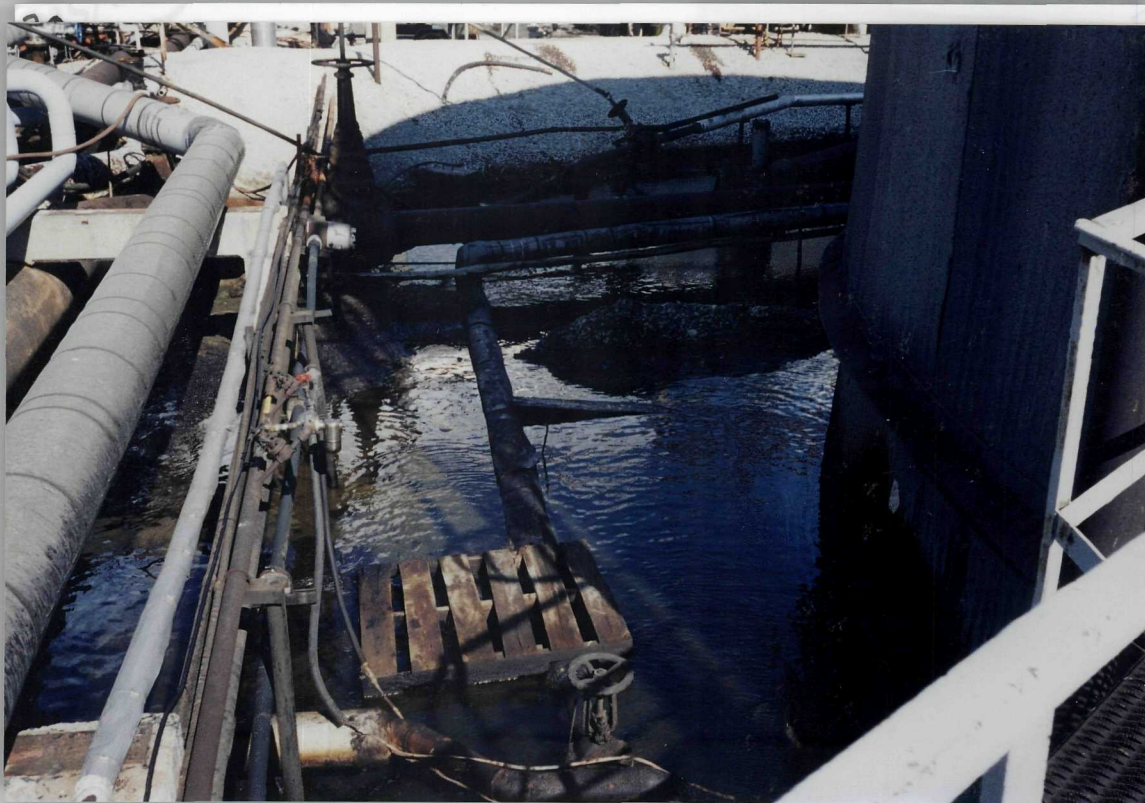
**TIME:** 11:30 **PHOTO:** 18  
**PHOTOGRAPHER:** Kirchner

After the drum storage and loading racks were inspected, the tour moved to the main refinery tank farm. During the March 1997 inspection, tank 35 contained some debris and a significant amount of water with oil floating on top of the water. During the February 1998 inspection, the tank 35 containment area still contained water and floating oil, although in less volume than in March 1997 (photos 18 and 19). Even though the volume was less, the tank was still encircled by water. The containment area for tank 17 had a small volume of water in it, but was heavily oil stained (photo 20). At the time of the inspection, Clark Oil Refinery had a subcontractor on site performing cleanup work in the containment area for tank 36 (photo 21). Mr. Huval did not know the nature of the spill in the tank 36 containment area.

**SUBJECT:** Oily water accumulated in containment area of Tank 35. The area shown in this photo is the same area represented in photo 5 from the March 1997 inspection.

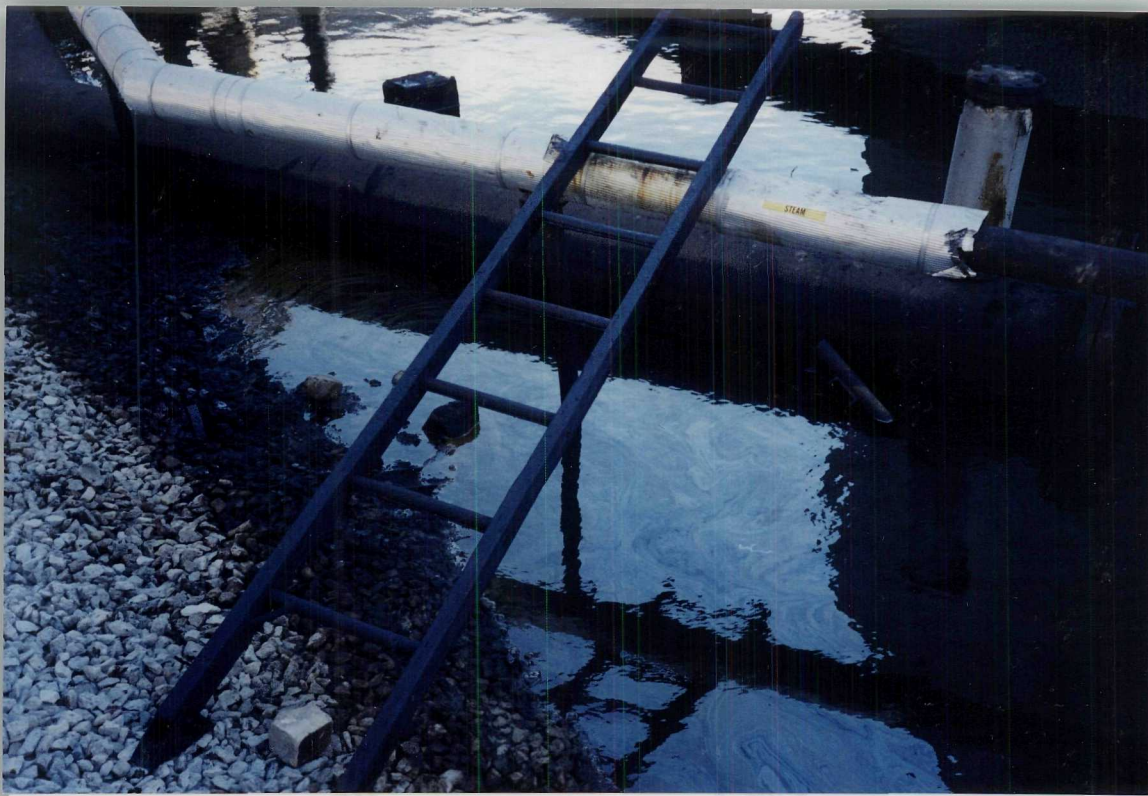
**SITE:** Clark Oil Refinery      **DATE:** February 27, 1998      **TIME:** 11:30      **PHOTO:** 19  
**LOCATION:** Blue Island, IL      **DIRECTION:** Southeast      **PHOTOGRAPHER:** Kirchner  
**SUBJECT:** Oil accumulation at Tank 35 and note level of oil staining. Same area as photo 13 from the March 1997 inspection.

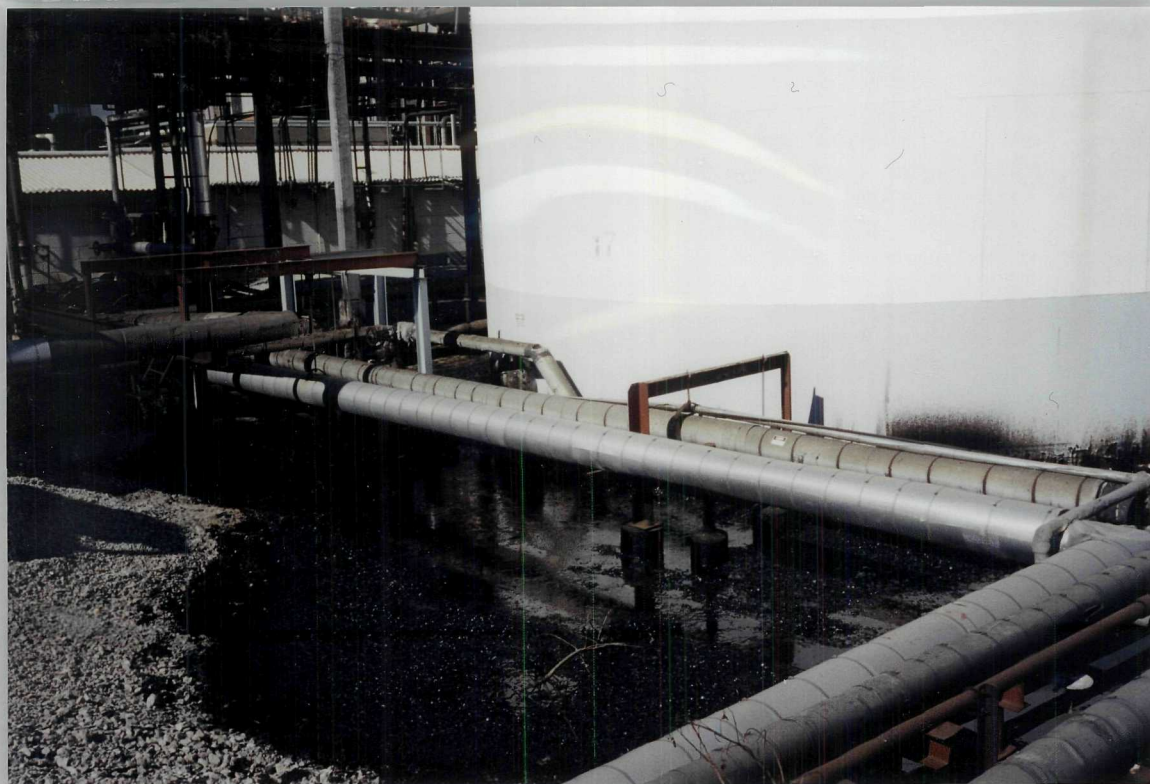
**SITE:** Clark Oil Refinery      **DATE:** February 27, 1998      **TIME:** 11:35      **PHOTO:** 20  
**LOCATION:** Blue Island, IL      **DIRECTION:** Northwest      **PHOTOGRAPHER:** Kirchner  
**SUBJECT:** Oil-stained ground in Tank 17 containment area. The area shown in this photo is the same area represented in photo 7 from the March 1997 inspection.

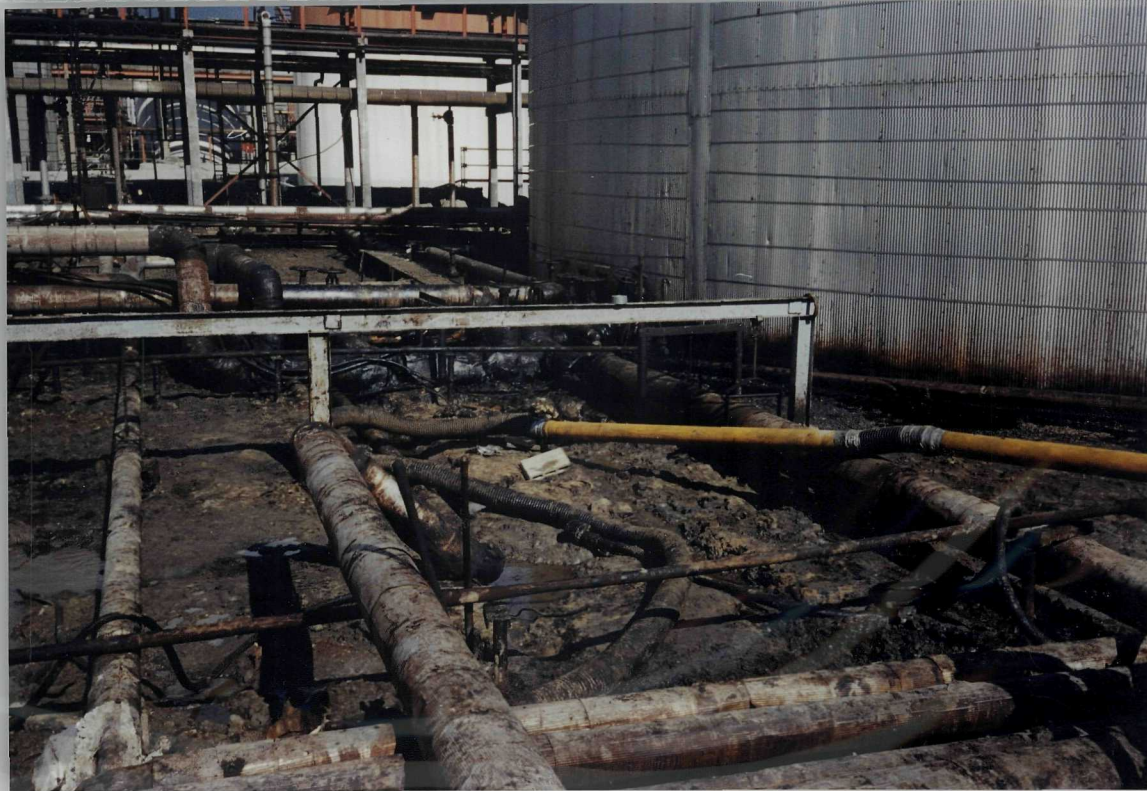
**TIME:** 11:40 **PHOTO:** 21  
**PHOTOGRAPHER:** Kirchner

**SITE:** Clark Oil Refinery  
**LOCATION:** Blue Island, IL  
**SUBJECT:** Cleanup work at Tank 36 containment area.

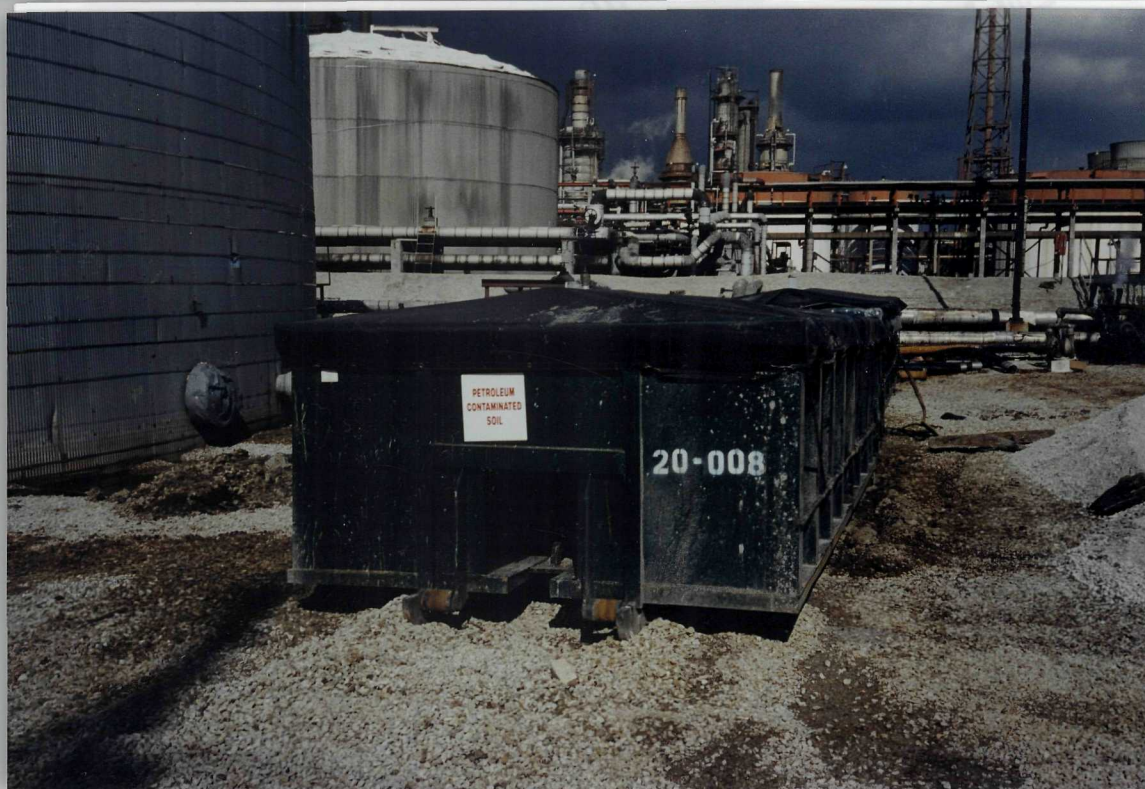
**TIME:** 11:50 **PHOTO:** 22  
**PHOTOGRAPHER:** Kirchner

**SITE:** Clark Oil Refinery  
**LOCATION:** Blue Island, IL  
**SUBJECT:** Rolloff boxes filled with petroleum-contaminated soils generated from cleanup of Tank 36 containment area.
